Hunshelf Park, Stocksbridge

*Stage 1 Road Safety
Audit Report*

October 2017

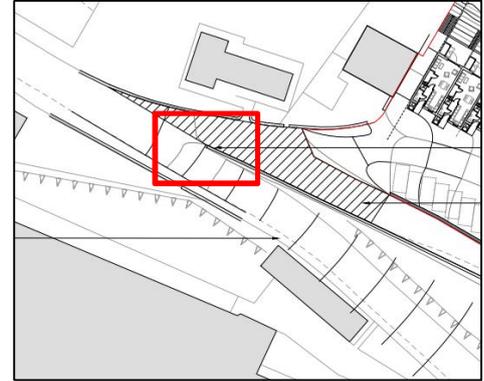
Problem: 3.1

Summary: Risk of injury to pedestrians and / or vehicle occupants due to low level retaining wall resulting in an inadequate barrier protection.

An existing, low height, retaining wall extends from the Hunshelf Park / Hunshelf Road junction, east, along Hunshelf Road. A note on drawing 3286 100 P 001A states that the proposal includes the '*lowering of the retaining wall to the lower side of the entrance*'.

The Audit Team has concerns that lowering the retaining wall to the lower side will result in a substandard provision of barrier between Hunshelf Road and Hunshelf Park. As such, there is a risk that pedestrians, especially children or visually impaired, may walk too close to the edge of the carriageway and fall down the embankment, potentially causing injury.

Furthermore, there is a risk that the resultant height of the retaining wall wouldn't provide suitable vehicle restraint. As such, should a motorist lose control of their vehicle, there is a possibility that an errant vehicle could veer from the road, down the embankment, possibly resulting in injury to all occupants of the vehicle.

Provide a vehicle / pedestrian restraint system to provide barrier protection in accordance with design standards.

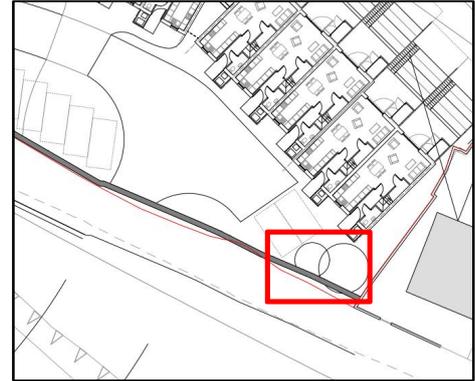
Problem: 3.2

Summary: Loss of parking provision may result in parking activity within unsafe locations, causing obstruction or obscuring forward visibility to oncoming motorists.

Drawing PT118-103 PL01 shows the extents of the housing development, including the length of retaining wall, located between the parking bays and Hunshelf Park. During the site visit, the Audit Team noted that the area of land, indicated above, is used as a car park by local residents. However, the proposal requires this land.

The Audit Team has concern that the loss of parking provision on Hunshelf Park may cause local residents to park in alternative, unsafe locations, causing obstruction which may result in side swipe collisions or obscuring forward visibility to other motorists. This issue creates a greater risk, should pedestrians on Hunshelf Park, masked by parked vehicles; step out into the path of an oncoming vehicle, as this may result in injury.

Realign the proposed wall to avoid removal of the existing parking area, or provide safe, alternative parking provision.

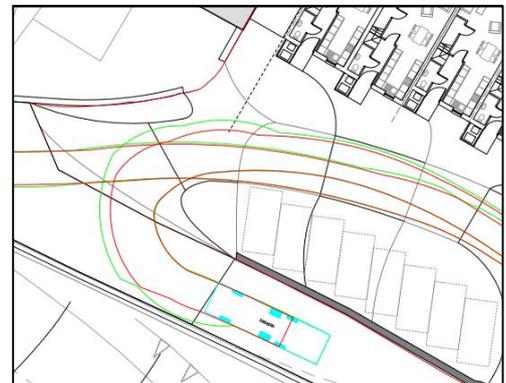
Problem: 3.3

Summary: Risk of collision between parked vehicles and larger vehicles accessing the housing development.

Drawing 3286 100 P 005A shows the location of the ten residential parking bays and a swept path analysis for a 'Dennis Eagle 6 x 2RS refuse vehicle' accessing the housing development.

The Audit Team has concerns regarding the swept path of the refuse vehicle and its close proximity to 'Bay 1'. There is a risk that a when parked, a vehicle in Bay 1 may overhang the marked area and encroach into the swept path, causing an obstruction to any vehicle passing. This may result in injury to anyone in the moving vehicle and damage to both vehicles involved.

Realign / reposition the parking bays or realign the access road to avoid potential conflict.

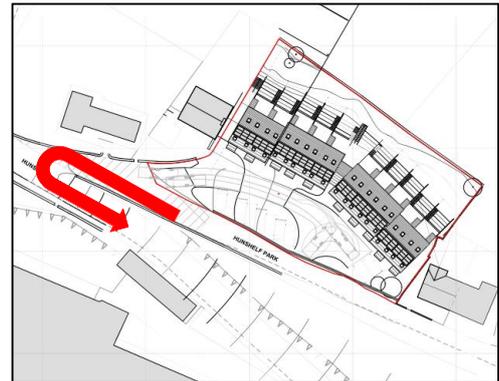
Problem: 3.4

Summary: Risk of head on collisions between motorists turning onto Hunshelf Road and oncoming motorists, resulting in injury to occupants of all vehicles, due to junction radii.

Drawings 3286 100 P 004A and 3286 100 P 005A both show the swept path analysis for refuse vehicle manoeuvres at the residential site / Hunshelf Park junction. However, there is no evidence to show the swept path analysis for vehicle manoeuvres at the Hunshelf Park / Hunshelf Road junction.

Based on observations made and from personal experience, the Audit Team has concerns with the tight radii for motorists to negotiate the turning manoeuvres at the Hunshelf Park / Hunshelf Road junction, particularly those making the left turn onto Hunshelf Road. As activity / traffic flow to and from Hunshelf Park will increase due to the additional housing, there is an increased risk of a head on vehicle collision between a motorist making the left turn manoeuvre and an oncoming, north-westbound, motorist. This may result in injury to occupants of all vehicles involved.

Provide a swept path analysis to demonstrate that all turning movements at the Hunshelf Park / Hunshelf Road junction can be accommodated safely.

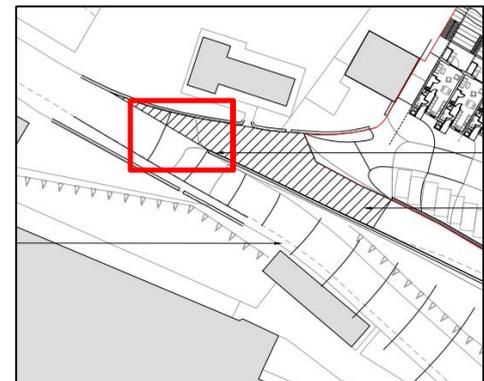
Problem: 3.5

Summary: Risk of head on collisions between motorists turning onto Hunshelf Road and oncoming motorists, resulting in injury to occupants of all vehicles, due to limited visibility.

Based on the information provided and observations made on site, the Audit Team has concerns regarding the forward visibility at the Hunshelf Park / Hunshelf Road junction. The alignment of the junction is such that forward visibility of oncoming vehicles, particularly for motorists turning onto Hunshelf Road, is poor. Motorists were observed to position their vehicle beyond the junction in order to see oncoming traffic. There is a risk that this will cause head on collisions between motorists turning onto Hunshelf Road and those approaching from either direction, possibly resulting in injury to occupants of all vehicles involved.

Provide evidence to show that the required visibility splays are provided at the Hunshelf Park / Hunshelf Road junction.

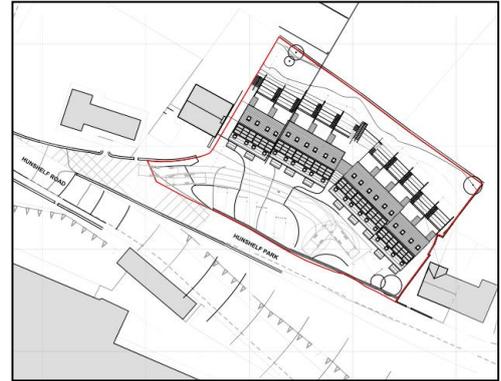
NON-MOTORISED USER PROVISION:**Problem:** 3.6*Location:* Car parking area*Drawing:* PT118-104 PL01 and 3286 100 P 001A*Summary:* Risk of pedestrian / vehicle collision due to a lack of pedestrian safe route within the residential area.

Drawings PT118-104 PL01 and 3286 100 P 001A show the proposed layout of the new housing development, indicating the proposed location for the ten properties and associated car parking spaces. However, the design does not show the provision of any pedestrian footway or a safe route connecting the car park area to the properties.

The Audit Team has concerns that without a formal designated pedestrian route, residents / visitors or other pedestrians may walk between the residential properties and the car parking spaces, into the path of oncoming vehicles which may result in injury if motorists are unable to stop in time. The concern is greater when considering the presence of larger vehicles such as a refuse collector, using the turning facility provided.

Provide a designated safe route for pedestrians to cross between the ten properties and associated car parking spaces.
